**Flood Control Project Maintenance  
Levee Inspections**

## Maintenance Issue Types Only, Levee Inspection Report By Mile - Spring 2019

### Knights Landing Ridge Drainage District

Waterway	Bank	Unit Miles	Inspection Start/End	Inspector
Unit No. 01 Knights Landing Ridge Cut	Right	6.36	04/04/2019 04/04/2019	Zach Jojola

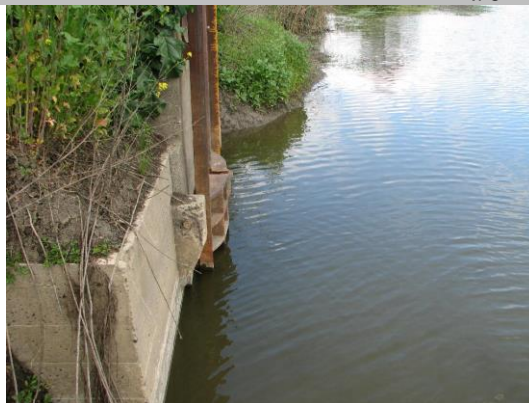
Photo 1 of 3 : UCIP\_SP\_2019\_13205\_21602.jpg

FS\_ID:13205  
DS\_ID:19391  
EP\_NO: 9307  
Repair Type: Non-Urgent  
Crossing Status: Found  
UCIP Comments: Walkway to actuator slide gate is missing. No method of actuating slide gate.  
FIELD\_STRUCT\_DESC: 2 of 2: 48-inch by 48-inch reinforced concrete box drainage culvert through the levee, 23 feet below the crown. Walkway to slide gate on the waterside (WS) end. Concrete headwalls on both ends. Service pole and anchor at the landside (LS) toe. Concrete headwalls on both ends. (four foot by four foot culvert [HLM 2.62] authorized under Automatic Board Order (ABO) issued as Permit No. 9307, 1974 - Azalene E. Lowe). [Additional Reference(s): DWR Levee Log, 1990. USACE Sacramento O&M Manual 127, June 1953, (Station 123+55.5)].  
FS Date: 4/5/2013

Slide gate and concrete headwall on WS toe.

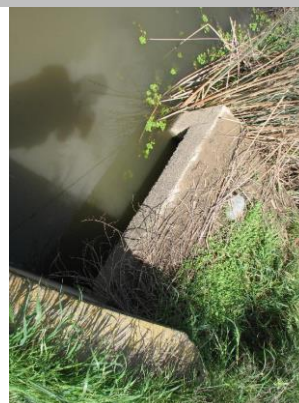
Photo 2 of 3 : UCIP\_SP\_2019\_13205\_21601.jpg

Concrete inlet on LS toe.

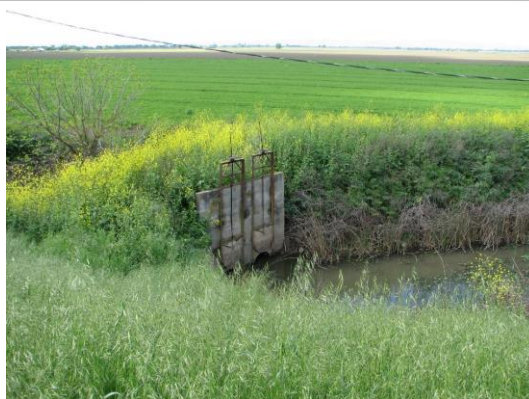
Photo 3 of 3 : UCIP\_SP\_2019\_13205\_21605.jpg

Inlet located next to concrete headwall on LS toe.

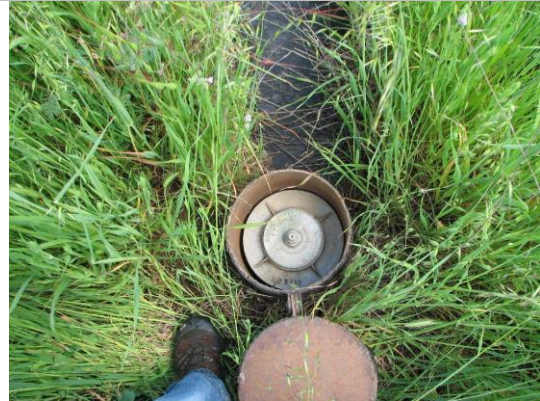
Photo 3 of 3 : UCIP\_SP\_2019\_16105\_27210.jpg

Siphon breaker on WS slope.

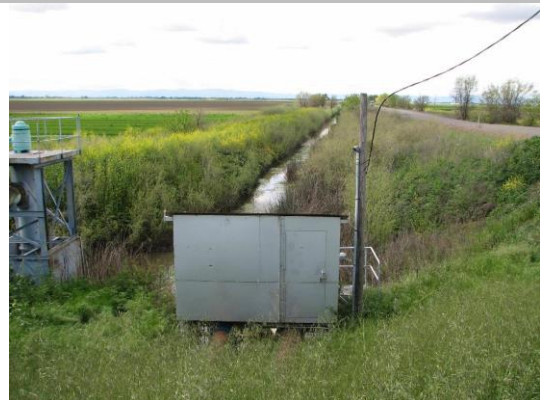
Photo 1 of 3 : UCIP\_SP\_2019\_16106\_27213.jpg

Pumphouse and pipe on LS toe.

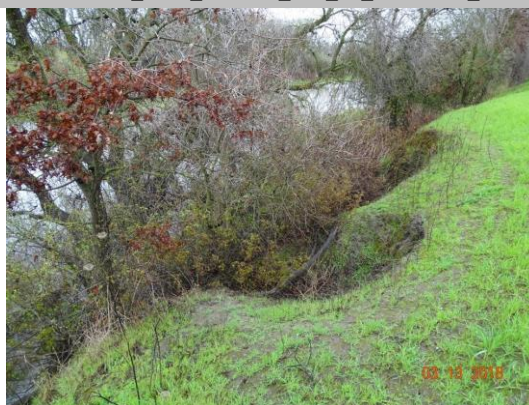
Photo 1 of 2 : SP\_2019\_NA0008\_256\_20\_20190304\_00005.jpg

LM Start	3.50	Rating **	M	Issue No.	20
LM End	3.50	Issue Type +	Ma	Location *	WS
Category	Earthen Levee			GPS Latitude/Longitude	
				Start	End
Item	Erosion / Bank Caving			38.759910 °	38.759910 °
				-121.696920 °	-121.696920 °
DWR ID	DWR_NA0008_01_f_2015_20				
Comment Code					
E2 : Schedule repair of erosion site prior to the next inspection.					
Inspector Comment

View of erosion on the waterside slope. Spring 2018.

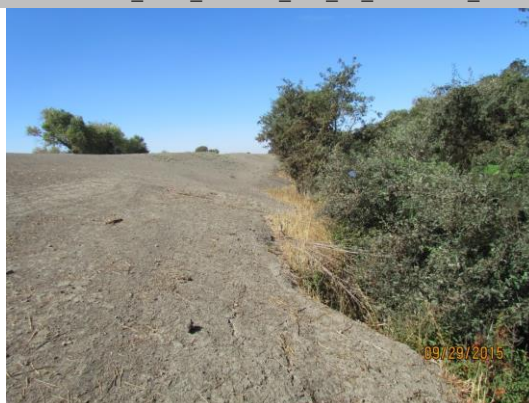
Photo 2 of 2 : SP\_2019\_NA0008\_256\_20\_20190304\_00006.jpg

View of the erosion on the waterward side of the levee looking upstream.  
Fall 2015.

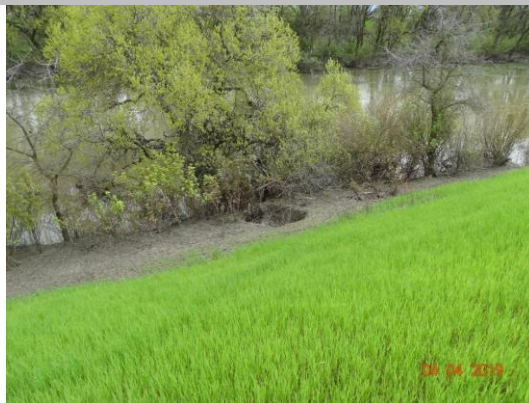
Photo 1 of 1 : SP\_2019\_NA0008\_256\_30\_20190404\_00040.jpg

LM Start	3.78	Rating **	M	Issue No.	30
LM End	3.78	Issue Type +	Ma	Location *	WS
Category	Earthen Levee			GPS Latitude/Longitude	
				Start	End
Item	Erosion / Bank Caving			38.762886 °	38.762886 °
				-121.700406 °	-121.700406 °
DWR ID	DWR_NA0008_01_s_2017_30				
Comment Code					
E2 : Schedule repair of erosion site prior to the next inspection.					
Inspector Comment					
There is a hole from a fallen tree at the waterside toe.

View of hole at the waterside toe. Spring 2019.

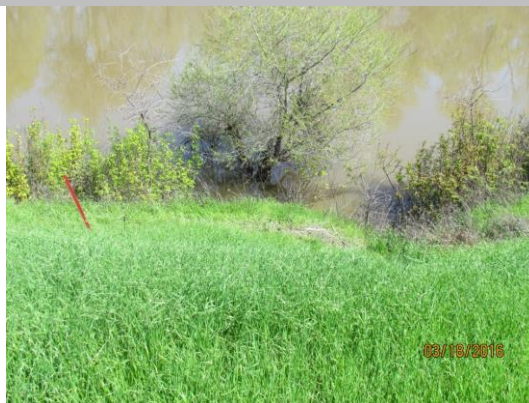
Photo 1 of 1 : SP\_2019\_NA0008\_256\_31\_20190304\_00011.jpg

LM Start	3.86	Rating **	M	Issue No.	31
LM End	3.86	Issue Type +	Ma	Location *	WS
Category	Earthen Levee			GPS Latitude/Longitude	
				Start	End
Item	Erosion / Bank Caving			38.763751 °	38.763751 °
				-121.701398 °	-121.701398 °
DWR ID	DWR_NA0008_01_s_2018_31				
Comment Code					
E1 : Note and monitor erosion site.					
Inspector Comment					
There is erosion at the toe of the levee. LMA is monitoring erosion with stakes.

View of the erosion at the toe of the levee on the waterward side. Spring 2016.

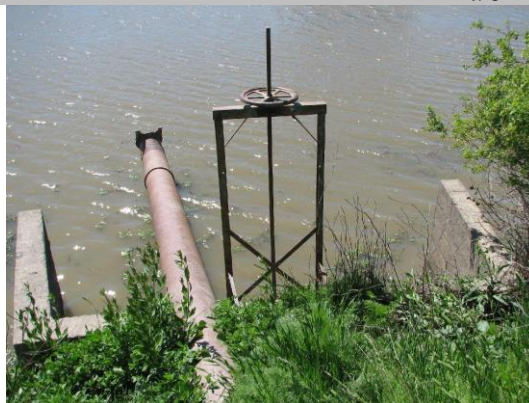
Photo 1 of 3 : UCIP\_SP\_2019\_52538\_18706.jpg

12-inch pipe at concrete headwall on WS toe.

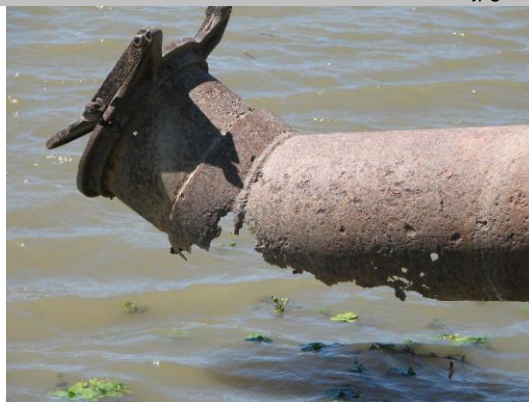
Photo 2 of 3 : UCIP\_SP\_2019\_52538\_18705.jpg

FS\_ID:52538  
DS\_ID:19371  
EP\_NO: 9320  
Repair Type: No Action Needed  
Crossing Status: Found  
UCIP Comments: 09/27/2017 see dsid 25471 for details on new pipe installed. (DWR UCIP - O. Magana)09/01/2016 Pipe has been removed and replaced during the Knights Landing 2015 Levee Repair Project. (T. Hatch/UCIP) 04/08/2013 Pipe at flap gate rusted through at WS toe. Flap gate does not function properly. (W. Wylie/UCIP) FIELD\_STRUCT\_DESC: \*REMOVED\* 1 of 2: 12-inch steel drainage pipe through the levee, 4 feet below the crown. Flap gate on the waterside (WS). Pipe is resting on a concrete headwall associated with another pipe. Siphon breaker in a 2-inch corrugated metal pipe (CMP) riser on the landside (LS) shoulder. Vertical pump unit on a concrete foundation in the irrigation ditch at the LS toe. (12-inch pipe [HLM 1.90] authorized under Automatic Board Order (ABO) issued as Permit No. 9320, 1974 - Ralph W. Pollock). [Additional Reference(s): DWR Levee Log, 1990. USACE Sacramento O&M Manual 127, June 1953, (Station 103+21.8)].

Pipe rusted through at flap gate on WS toe.

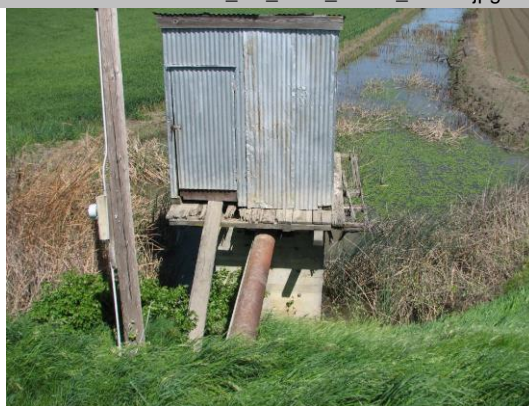
Photo 3 of 3 : UCIP\_SP\_2019\_52538\_18704.jpg

Pumphouse on concrete platform on LS toe with JP.

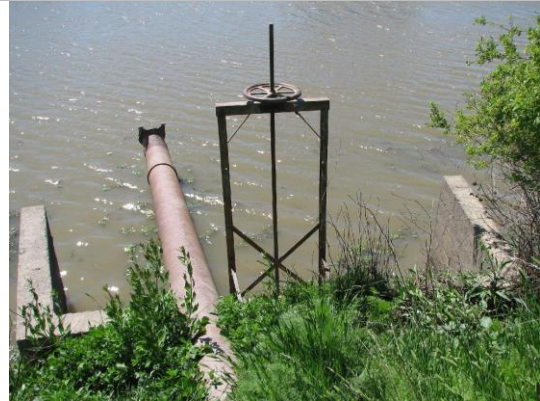
Photo 3 of 3 : UCIP\_SP\_2019\_11305\_18701.jpg

Slide gate at headwall on WS toe.

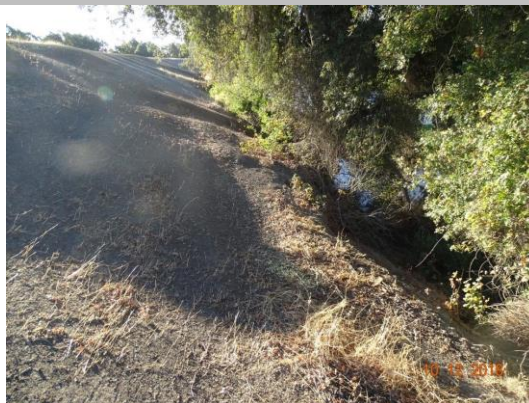
Photo 1 of 2 : SP\_2019\_NA0008\_257\_9\_20190304\_00003.jpg

LM Start	2.98	Rating **	M	Issue No.	9
LM End	3.11	Issue Type +	Ma	Location *	WS
Category	Supplemental			GPS Latitude/Longitude	
				Start	End
Item	2017 USACE Erosion Survey, DRAFT			38.758587 °	38.760053 °
				-121.693359 °	-121.694686 °
DWR ID	DWR_NA0008_02_f_2018_9				
Comment Code					
Inspector Comment					
2017 Site ID: KLR 3.1 L					
Status: Eroding					
2017 Field Notes: Access Issues - Could not observe					
Site History: 2006 - The whole levee toe area is slowly slumping into the channel (creep) due to dewatering and poor slope soils. Occasional piping in the levee slope evident as well. Pistol-butted trees at the levee toe indicate slow retreat. 2011 - Slumping of the levee toe.

View of the erosion on the waterside slope. Fall 2018.

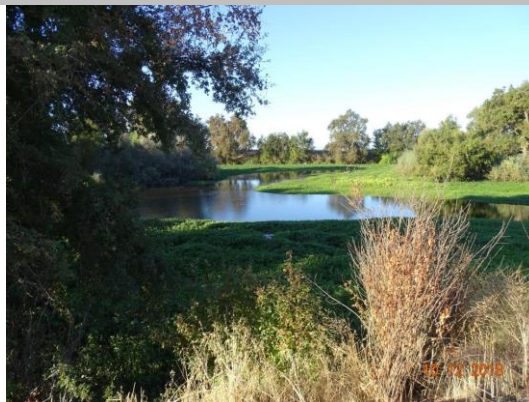
Photo 2 of 2 : SP\_2019\_NA0008\_257\_9\_20190304\_00004.jpg

View of the opening within the center channel. Fall 2018.

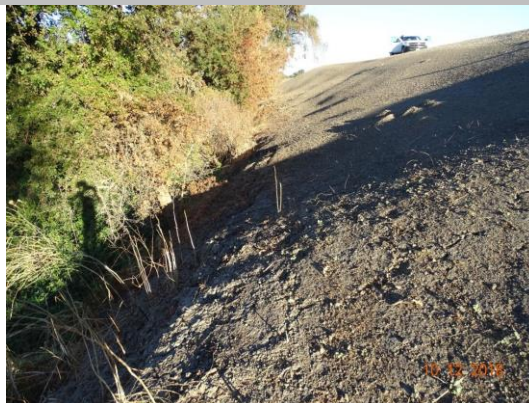
Photo 1 of 2 : SP\_2019\_NA0008\_257\_14\_20190304\_00005.jpg

LM Start	3.31	Rating **	A/W	Issue No.	14
LM End	3.31	Issue Type +	Ma	Location *	WS
Category	Earthen Levee			GPS Latitude/Longitude	
				Start	End
Item	Erosion / Bank Caving			38.762301 °	38.762301 °
				-121.697190 °	-121.697190 °
DWR ID	DWR_NA0008_02_f_2018_14				
Comment Code					
E1 : Note and monitor erosion site.					
Inspector Comment					
The primary channel changes course throughout the water year and erodes the slope through an opening in the center barrier. The slope appears to be stable and erosion is not within the prism. The levee is further reinforced by the newly constructed berm on the land side. Recommend monitoring.

View of erosion on the waterside slope. Fall 2018.

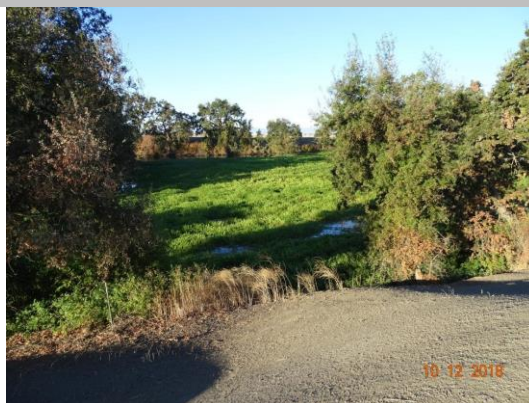
Photo 2 of 2 : SP\_2019\_NA0008\_257\_14\_20190304\_00006.jpg

View of the opening within the main channel, facing upstream. Fall 2018.

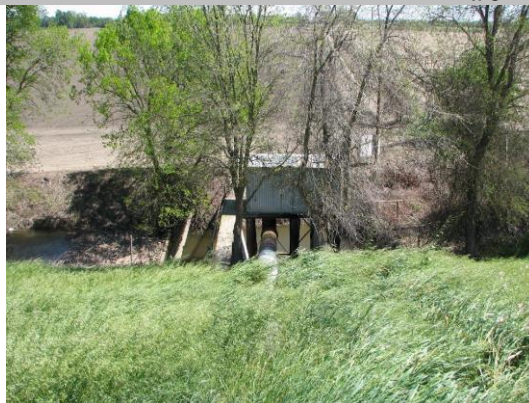
Photo 1 of 3 : UCIP\_SP\_2019\_11293\_18675.jpg

Pump on LS toe.

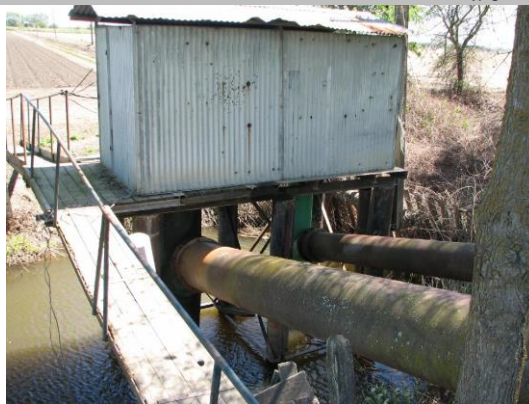
Photo 2 of 3 : UCIP\_SP\_2019\_11293\_18674.jpg

Pump and pipes on LS toe.

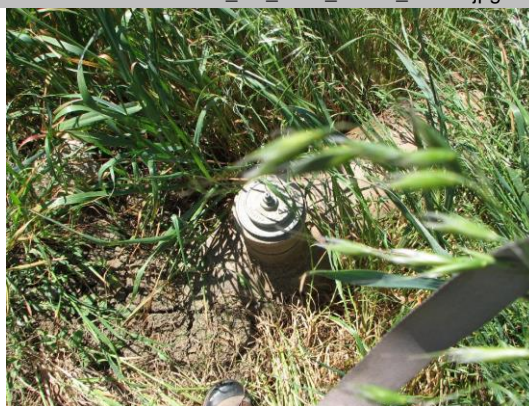
Photo 3 of 3 : UCIP\_SP\_2019\_11293\_18673.jpg

16-inch pipe with siphon breaker on WS shoulder.

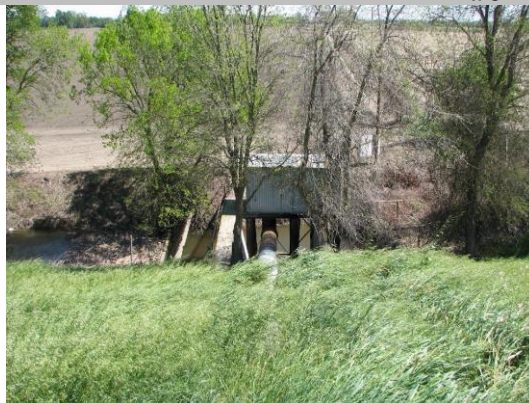
Photo 1 of 3 : UCIP\_SP\_2019\_11291\_18669.jpg

Pumphouse at LS toe.

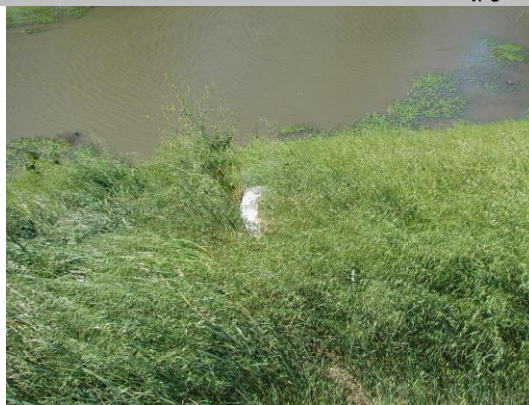
Photo 2 of 3 : UCIP\_SP\_2019\_11291\_18668.jpg

Pipe in grass on WS shoulder.

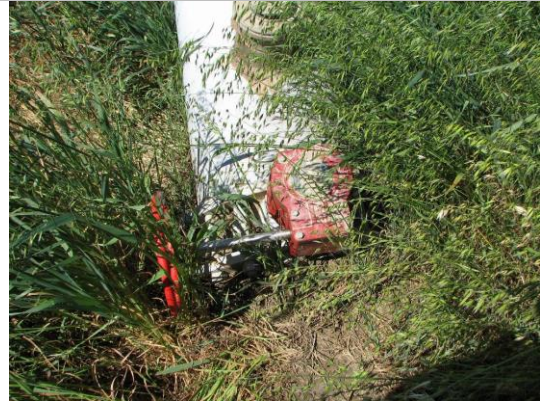
Photo 3 of 3 : UCIP\_SP\_2019\_11291\_18667.jpg

Siphon breaker and butterfly valve on WS shoulder.

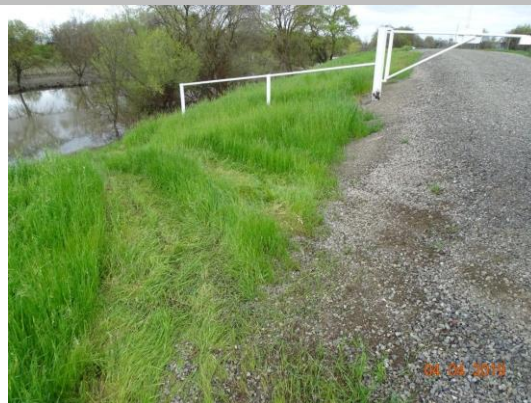
Photo 1 of 1 : SP\_2019\_NA0008\_257\_17\_20190404\_00029.jpg

LM Start	5.78	Rating **	M	Issue No.	17
LM End	5.78	Issue Type +	Ma	Location *	WS
Category	Earthen Levee			GPS Latitude/Longitude	
				Start	End
Item	Slope Stability			38.791059 °	38.791059 °
				-121.722060 °	-121.722060 °
DWR ID	DWR_NA0008_02_s_2019_17				
Comment Code					
S3 : Repair the levee slope damaged by vehicle traffic and prevent access where possible.					
Inspector Comment					
There are tire ruts on the waterside slope. LMA will extend pipe fence to prevent traffic from driving on the slope.

View of tire tracks on the waterside slope. Spring 2019.
